Impulse Waves Generated By Rockfalls: Run-Up Assessment Along a Lakeshore (Lake Lucerne, Central Switzerland)

Erni, C.^{1,*}, Buckingham, T.¹, Louis, K.¹, Fuchs, H.², Boes, R.², Pedrazzini, A.³, Jaboyedoff, M.³

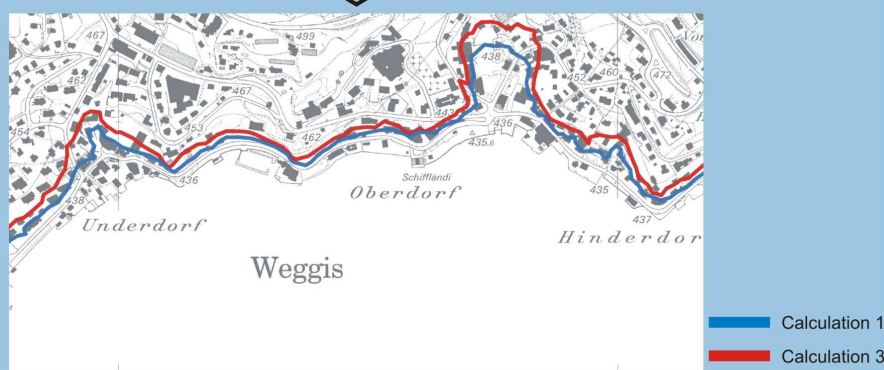
Fig. 6 Mapdetail showing the areas with a wave overtopping impact for calculation 1 and 3.

Calculation 1	Calculation 2	Calculation 3
Bulk slide volume [m ³]	20'000	40'000	60'000
Run-up height [m]	7.6	12.4	15.2
Overtopping volume per 1m shoreline [m ³ /m]	118	245	331

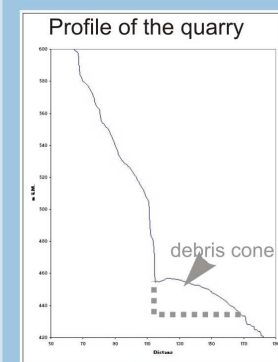
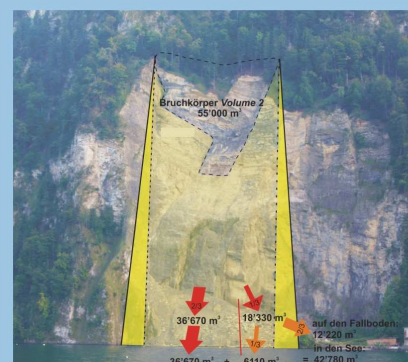
Fig. 7 Actual state of the quarry base.

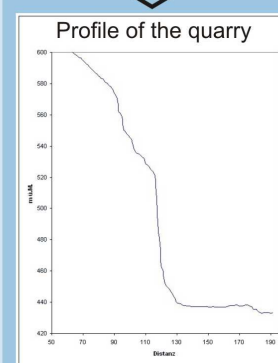
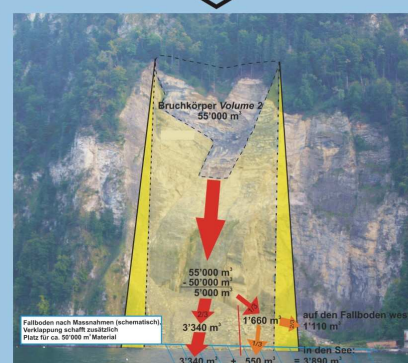
Fig. 8 Cleaned quarry base.

Clearance of the quarry
